Pipeline and Hazardous Materials Safety Administration

Office of Pipeline Safety

Construction & Material Quality Issues

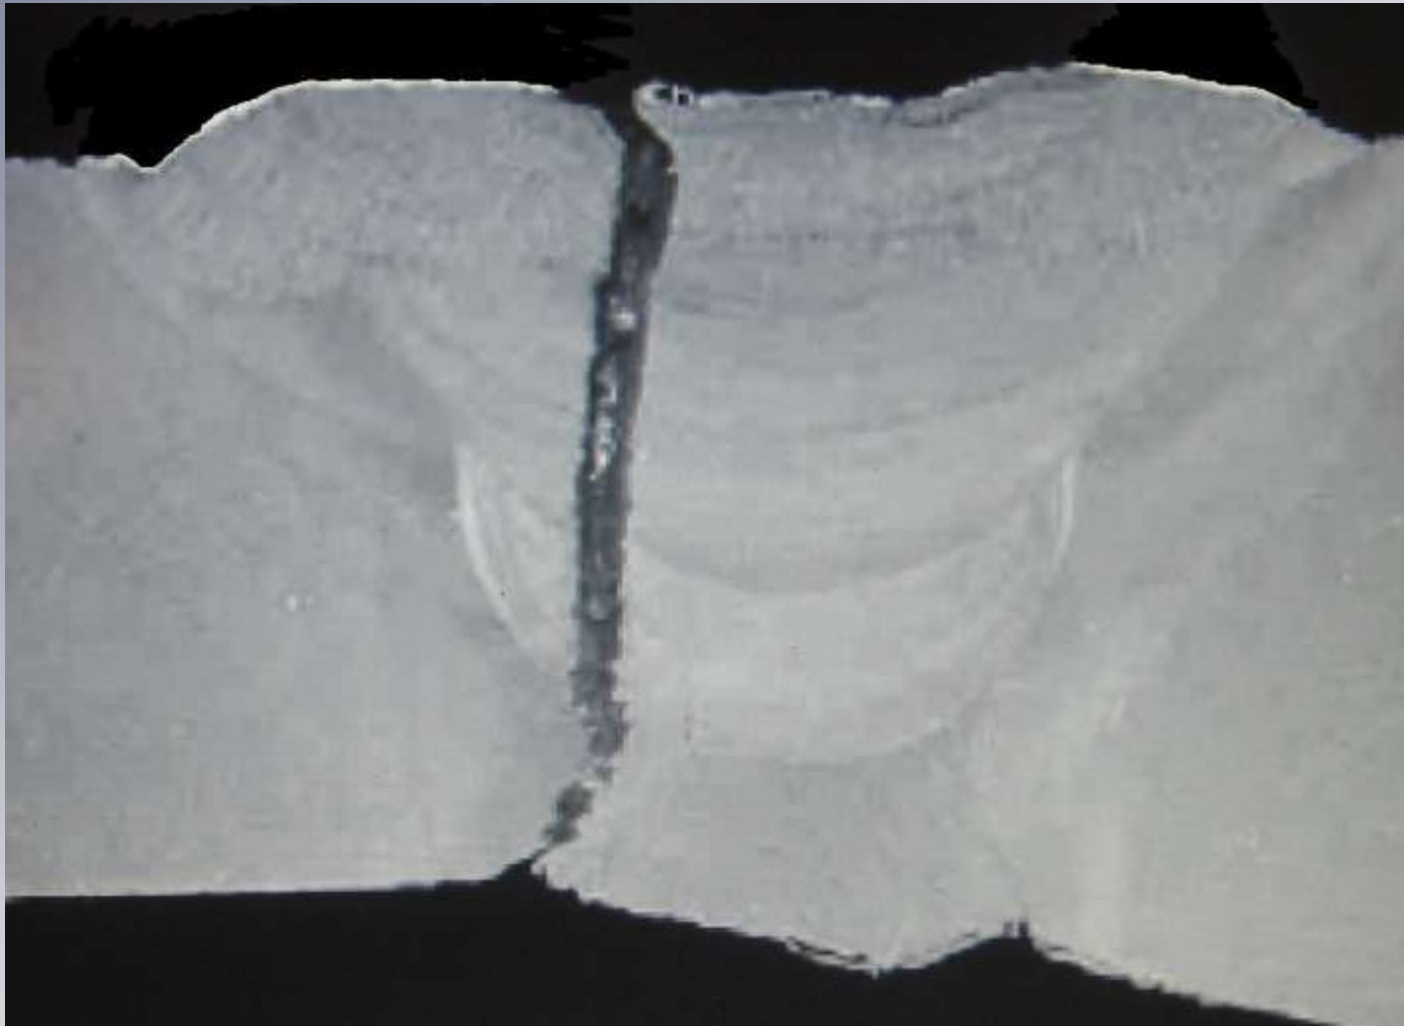
Hydrogen Cracking

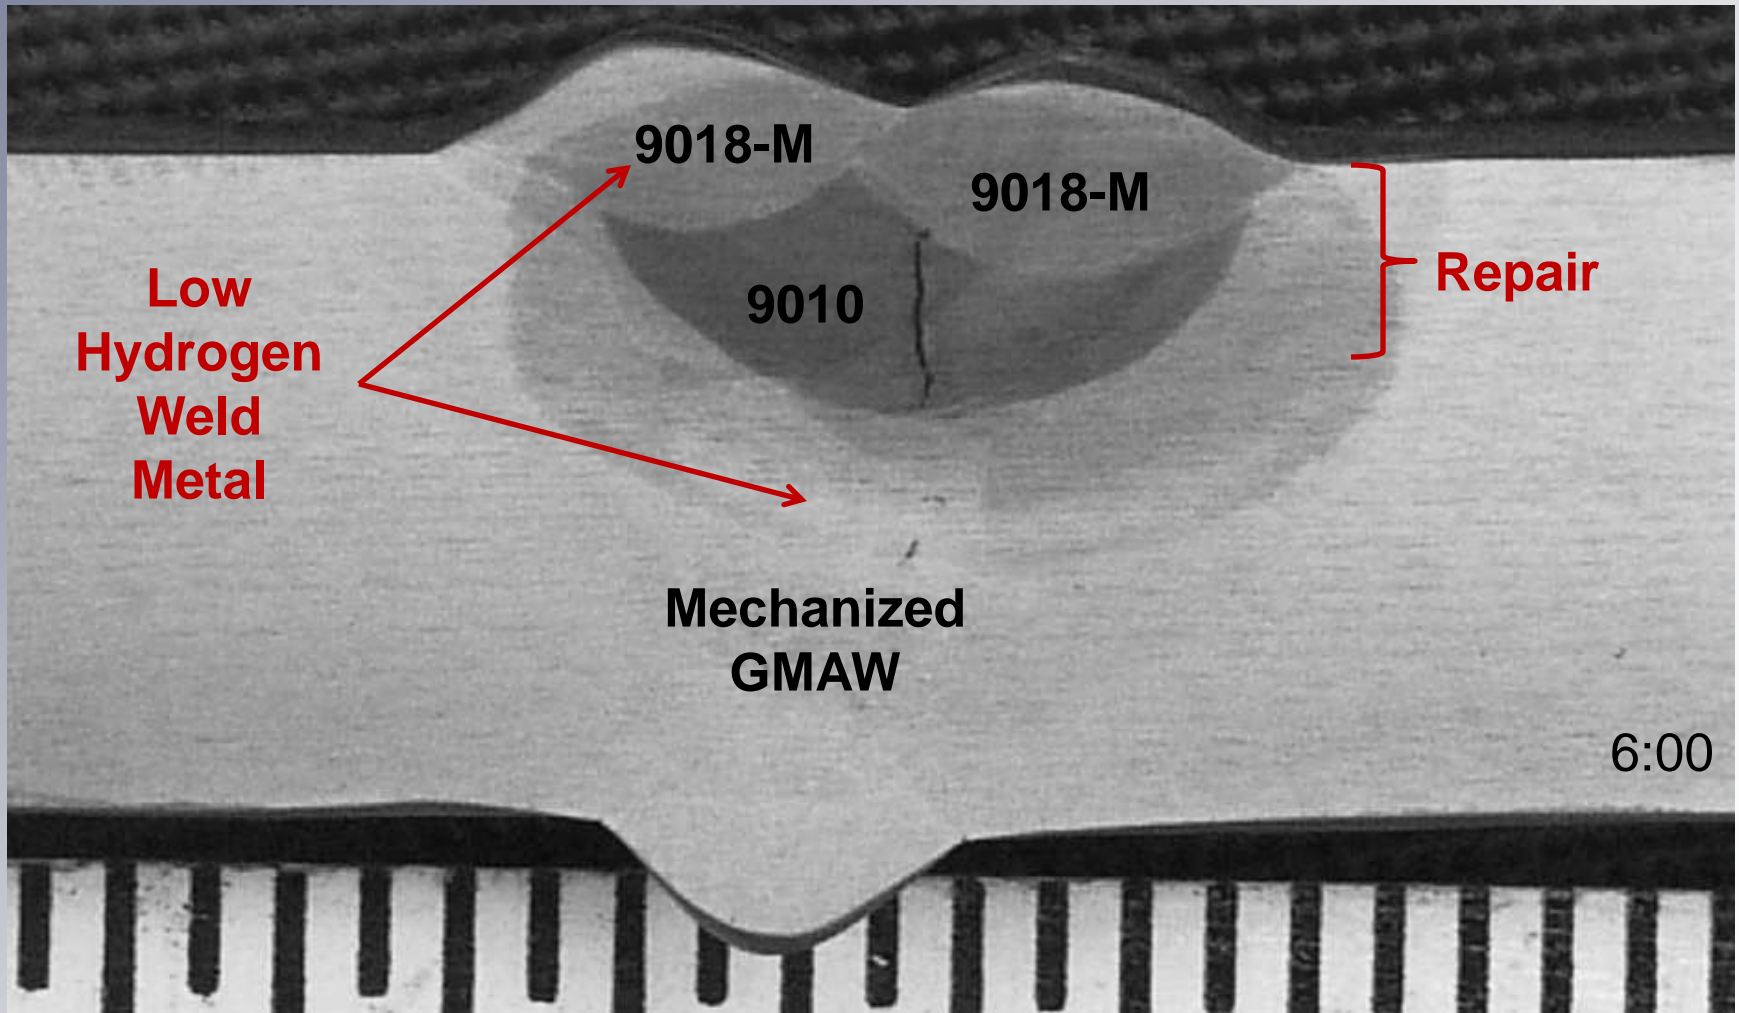
Partial Thickness Repair: Only 1 Cellulosic Weld Pass

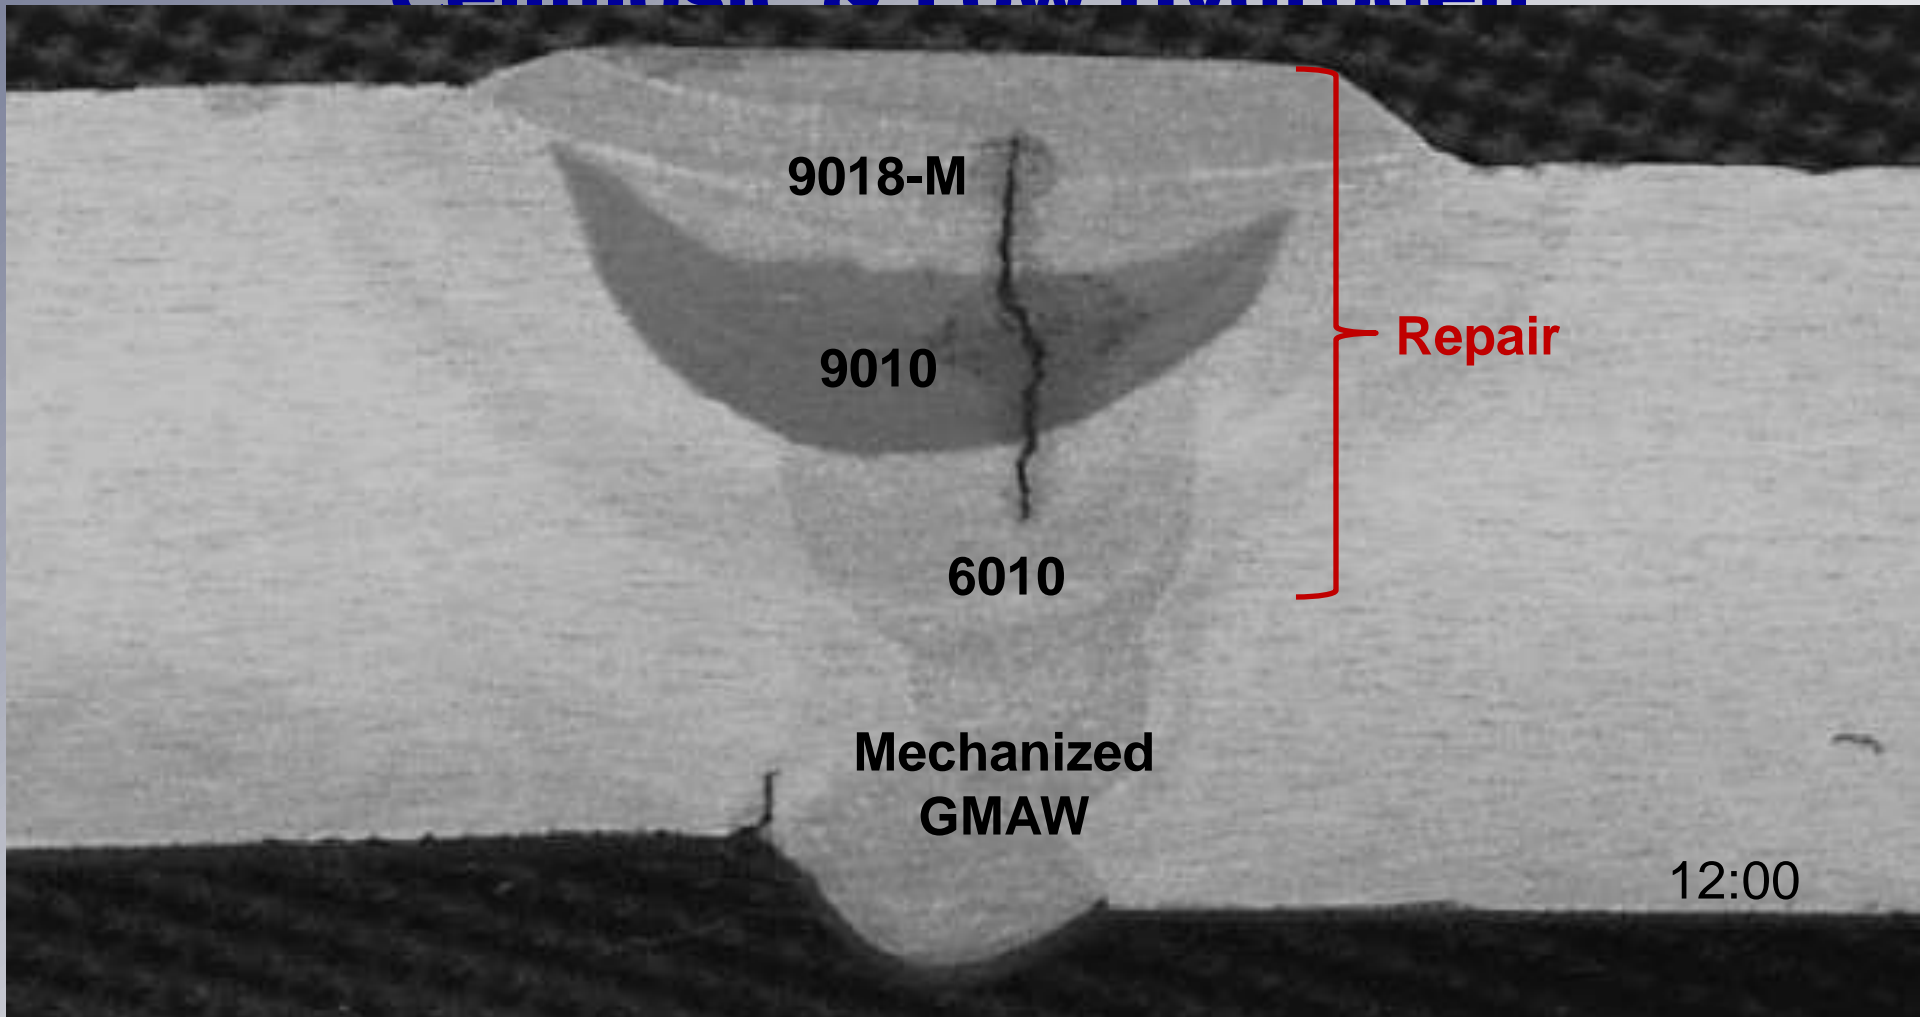
Partial Thickness Repair: Cellulosic & Low Hydrogen

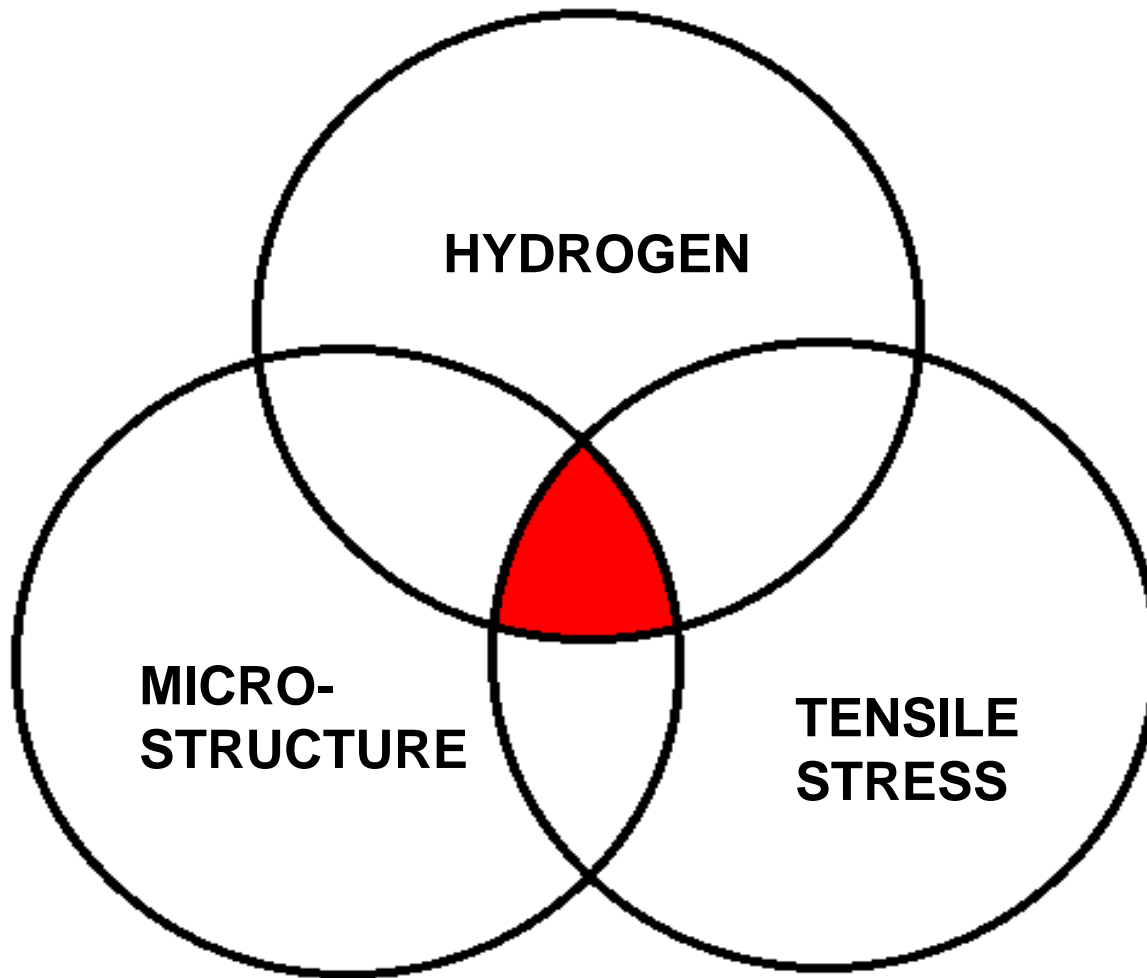
Hydrogen Cracking

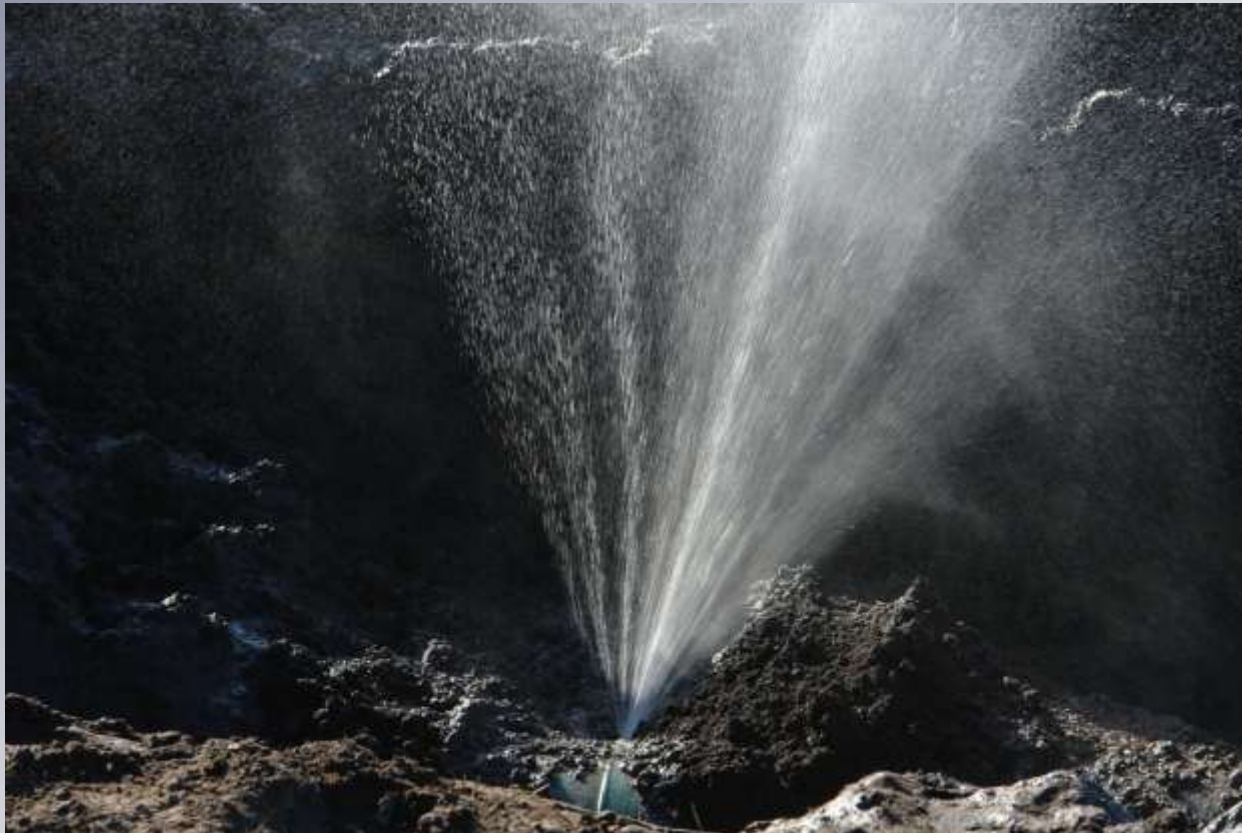
Construction Issues – cracked girth weld

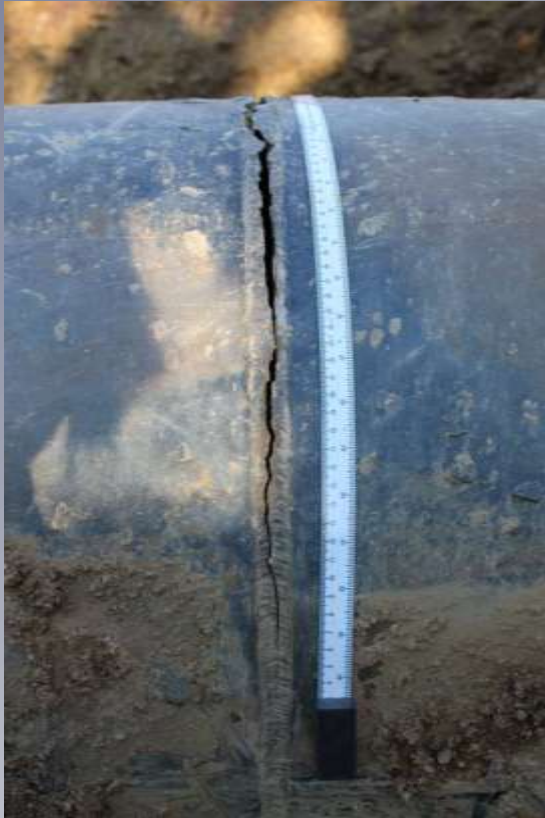
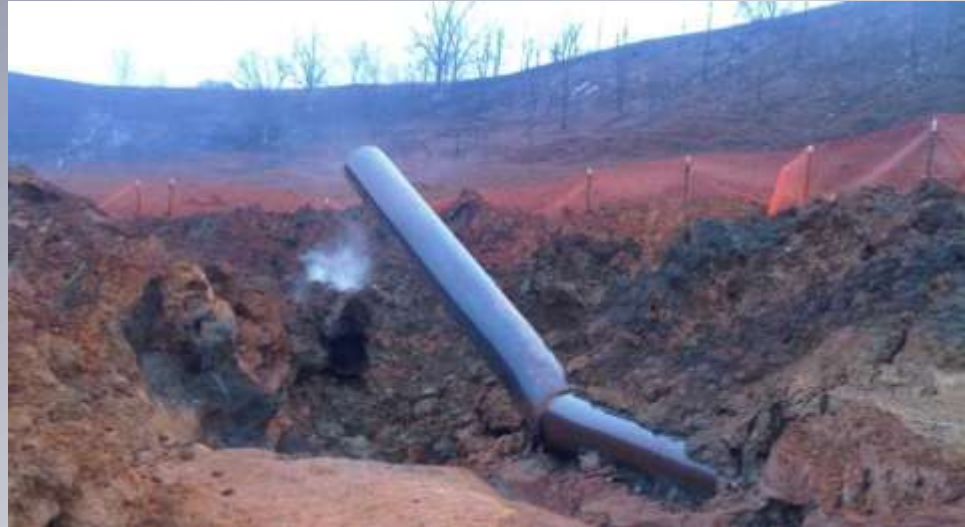
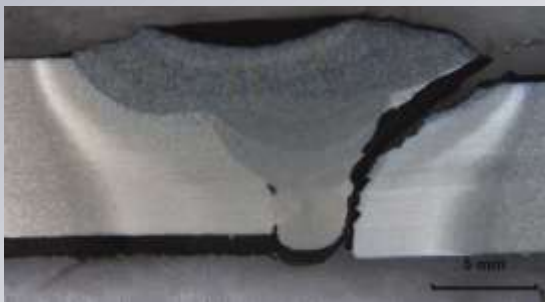
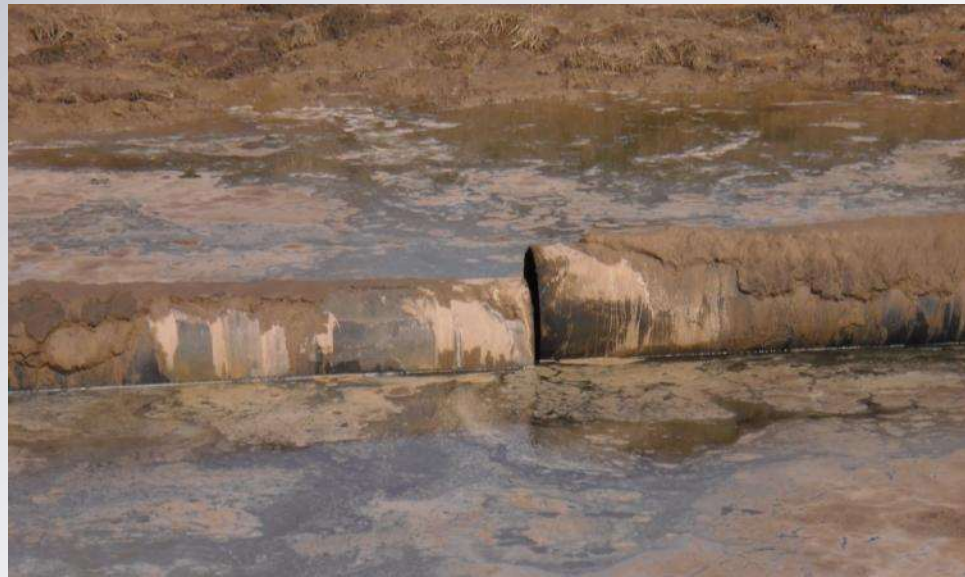
Recent Girth Weld Incidents

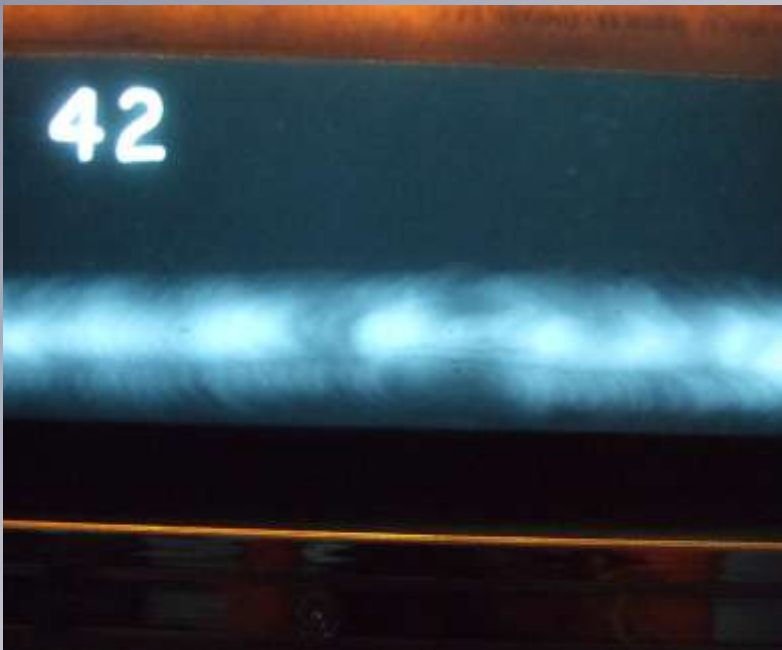
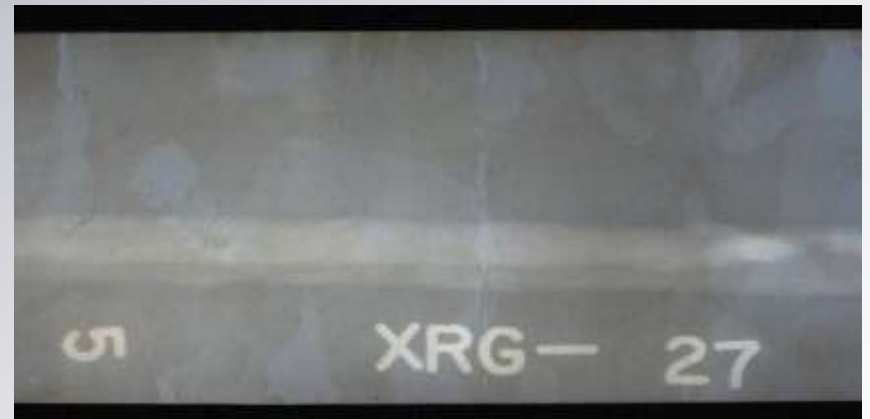
- **Poor radiographic quality**

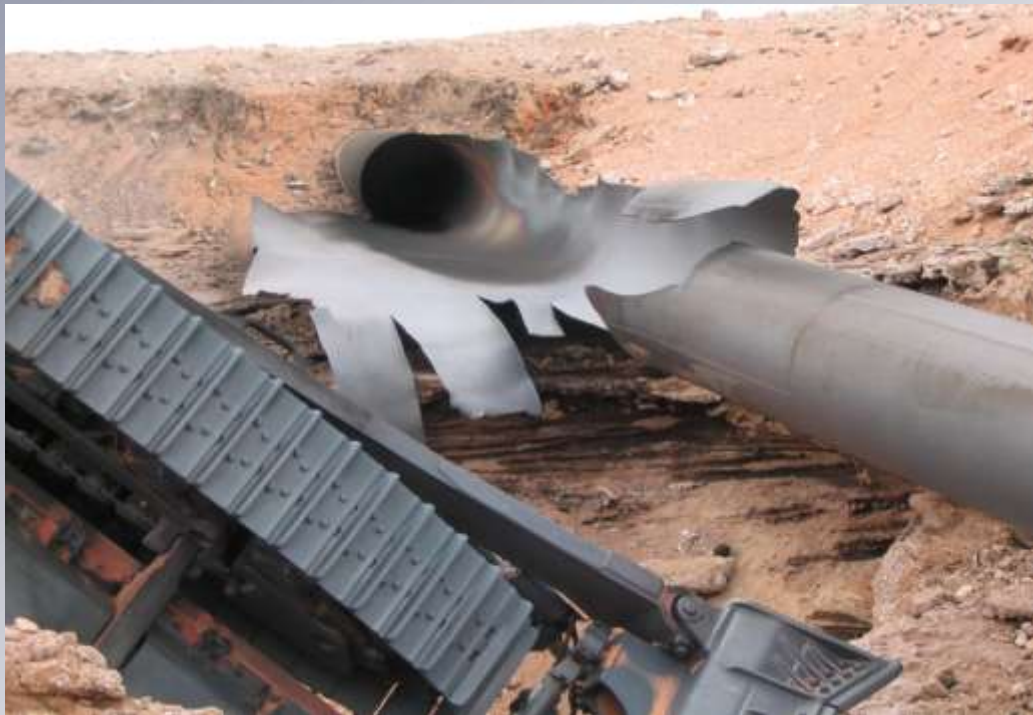
- **2nd /3rd Party Damage to Adjacent Pipeline**
